The Berger Manufacturing Co.
Canton, Ohio

Fire, Water and Load Tests on
Berger's *Metal Lumber* System
(Patented)

Pressed Steel Fireproof Construction

These Tests are designed to produce as near as possible the maximum conditions which prevail in large conflagrations and at the same time provide means of accurately recording the action of the material at all times. ∴ ∴

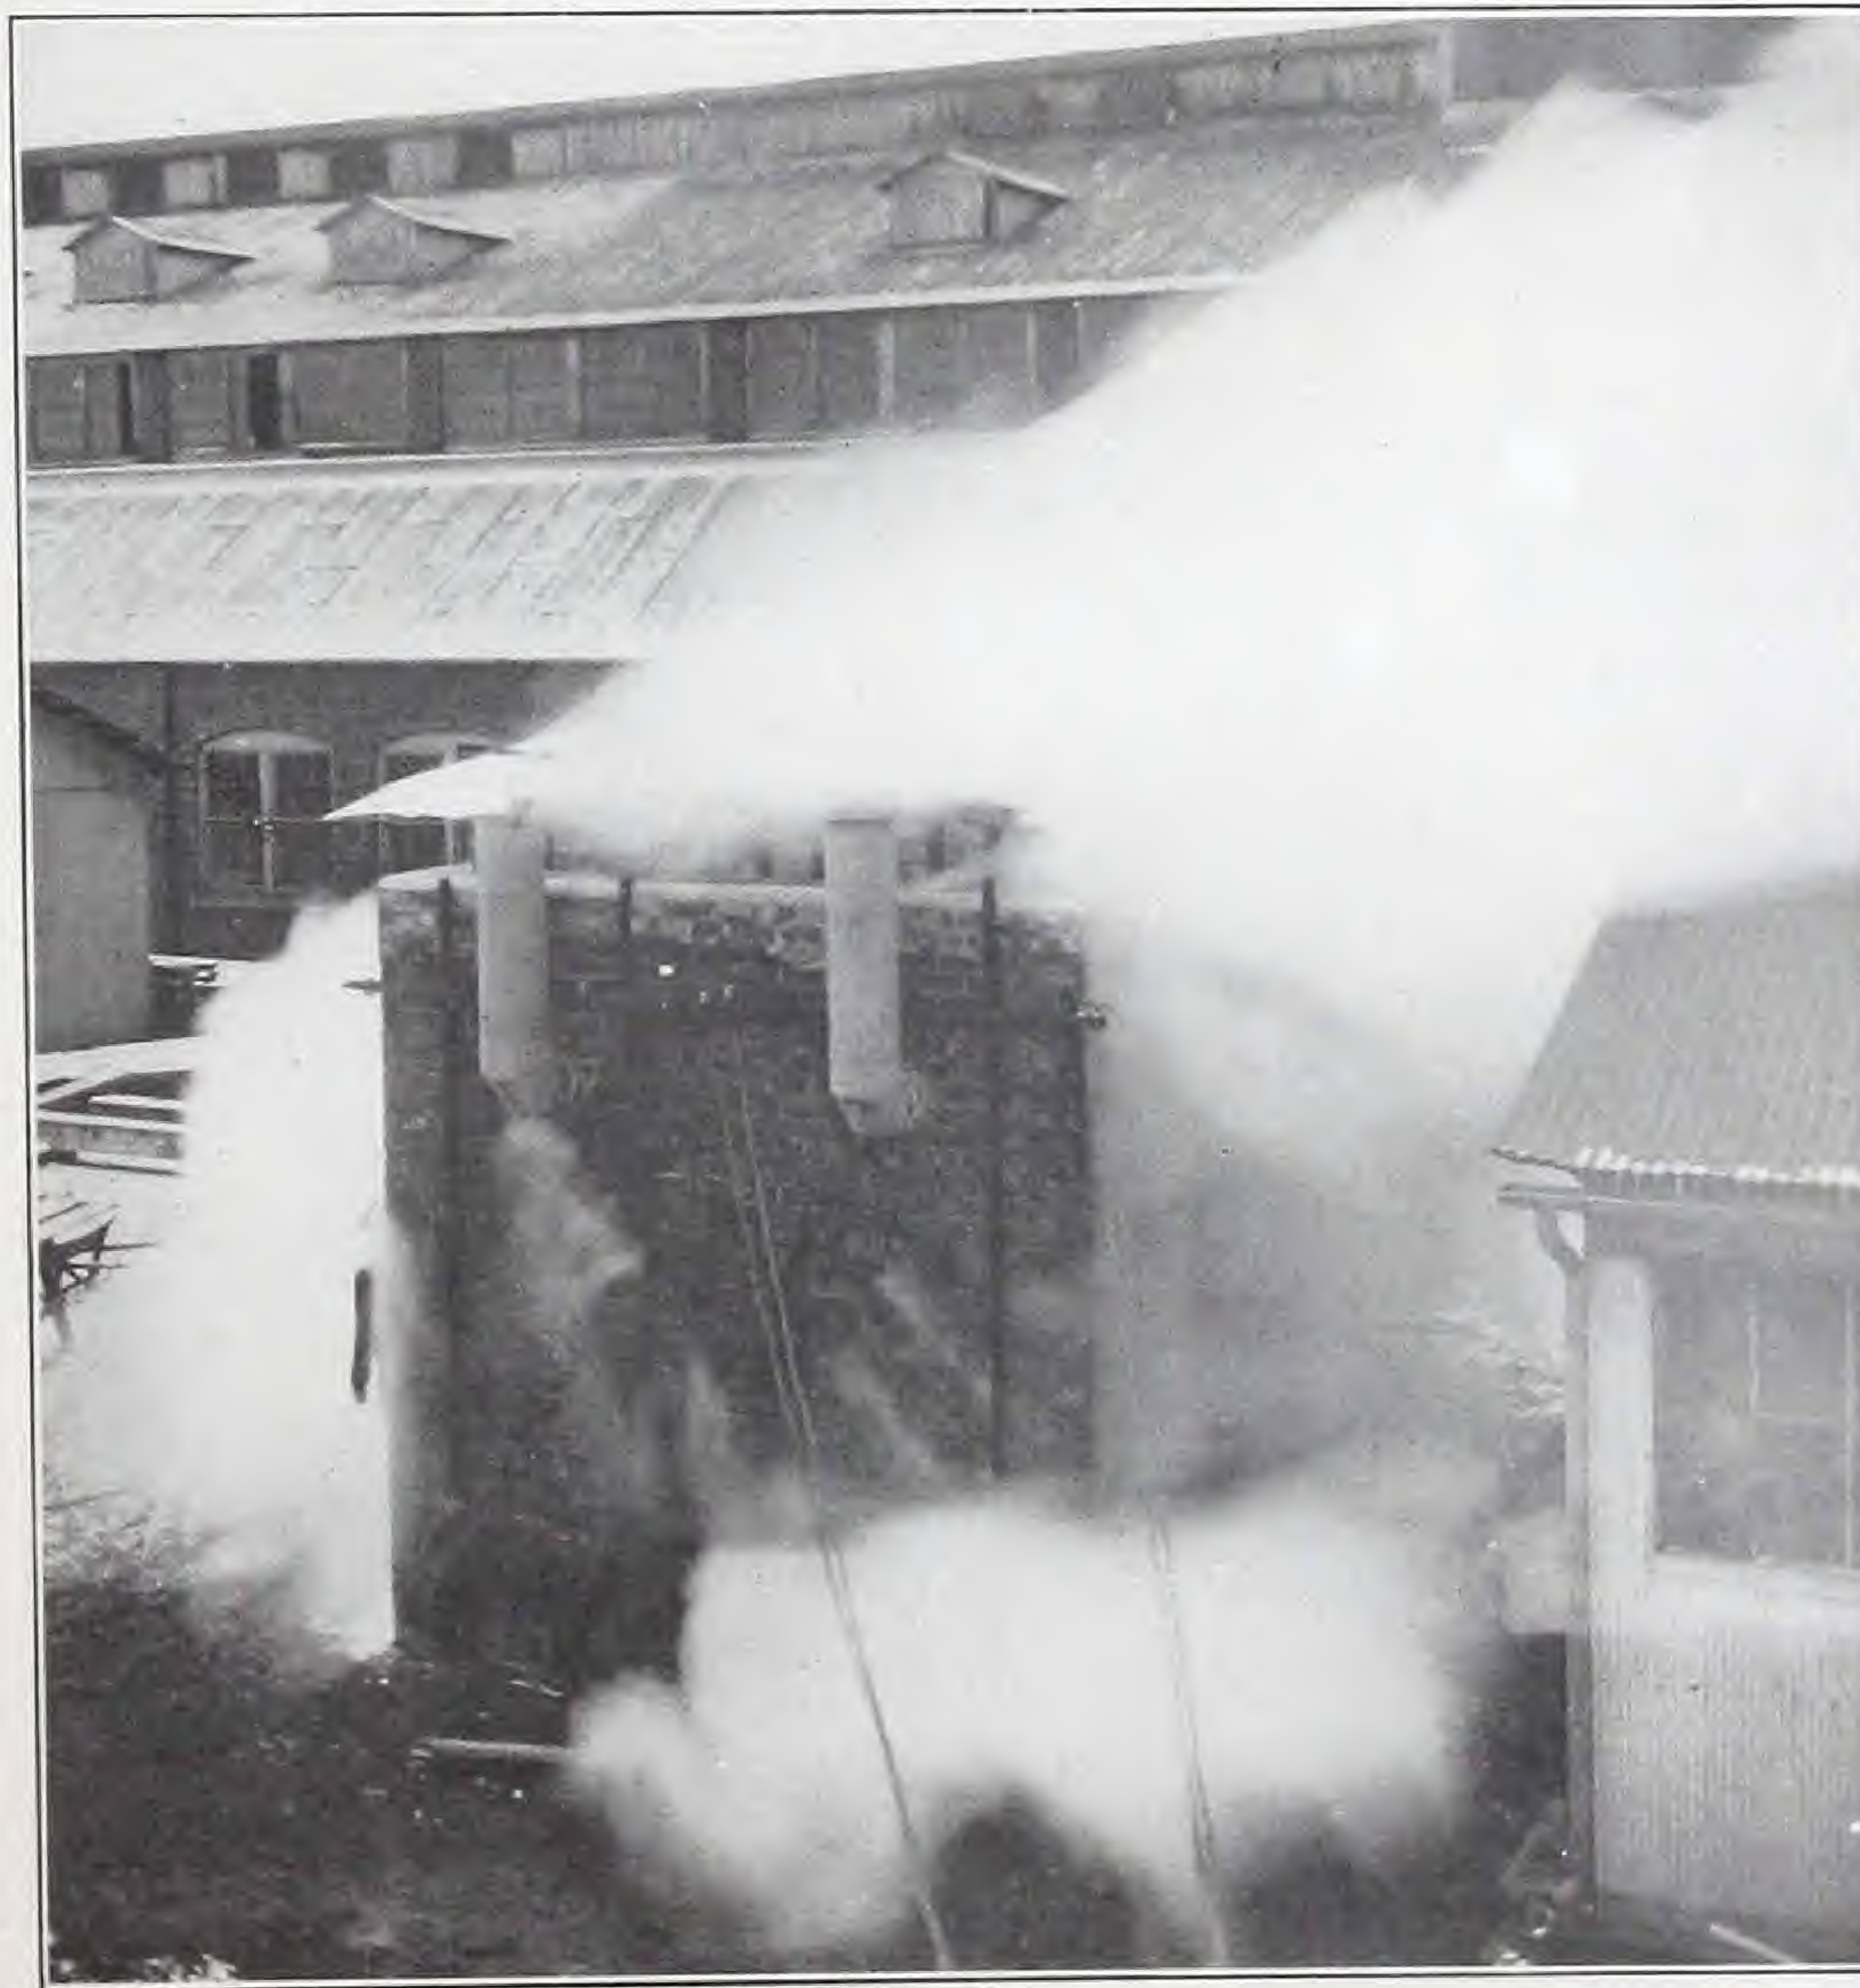
Water Applied to Furnace Ceiling, Pressure 65 lbs. per Square Inch at Hydrant and Carried by $2\frac{1}{2}$ -inch Cotton Hose with $1\frac{1}{8}$ -inch Nozzle.

at a distance of not more than 10 feet from the end of the nozzle. Approximately 4 square feet of lath was exposed after the stream had been applied for five minutes. Water was then applied to the top of the slab by means of a small garden hose and the furnace thoroughly cooled.

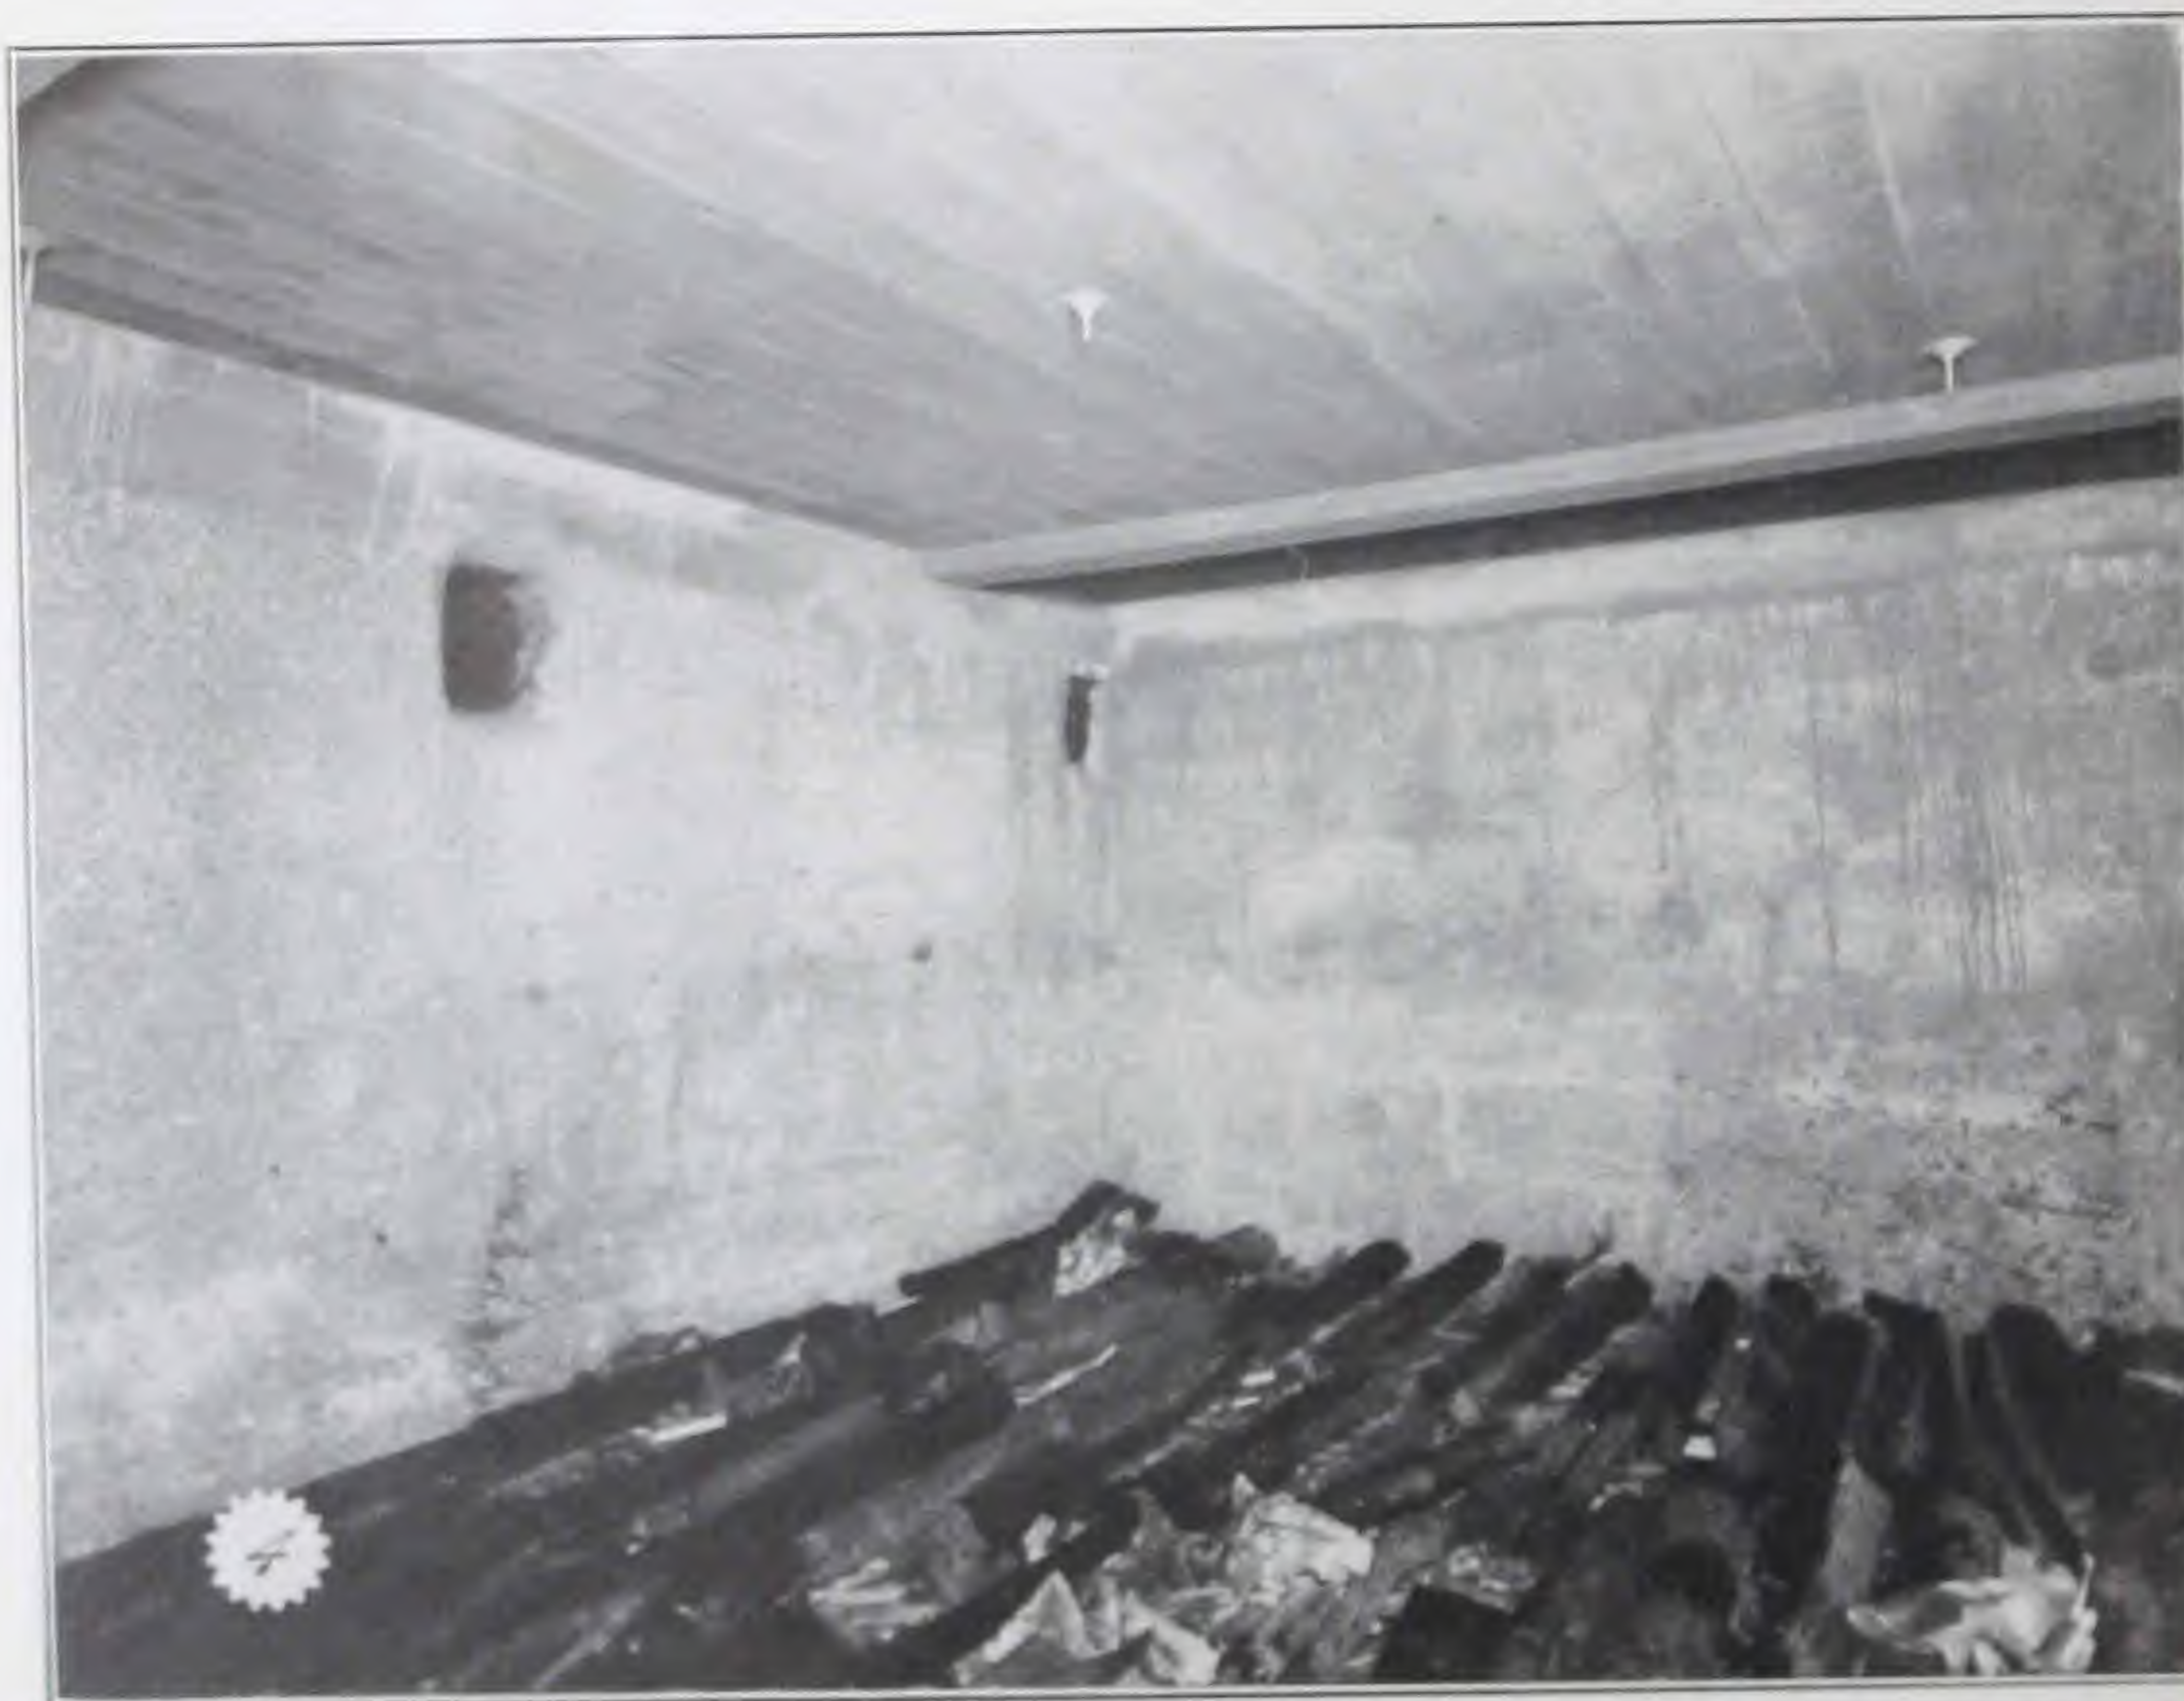
Ceiling just Before the Fire Test. Thermo-couples can be seen Projecting Below the Ceiling.

The temperature was obtained by means of thermo-couples suspended through the floor with the junction about 6 inches below the ceiling. Refer to photograph above.

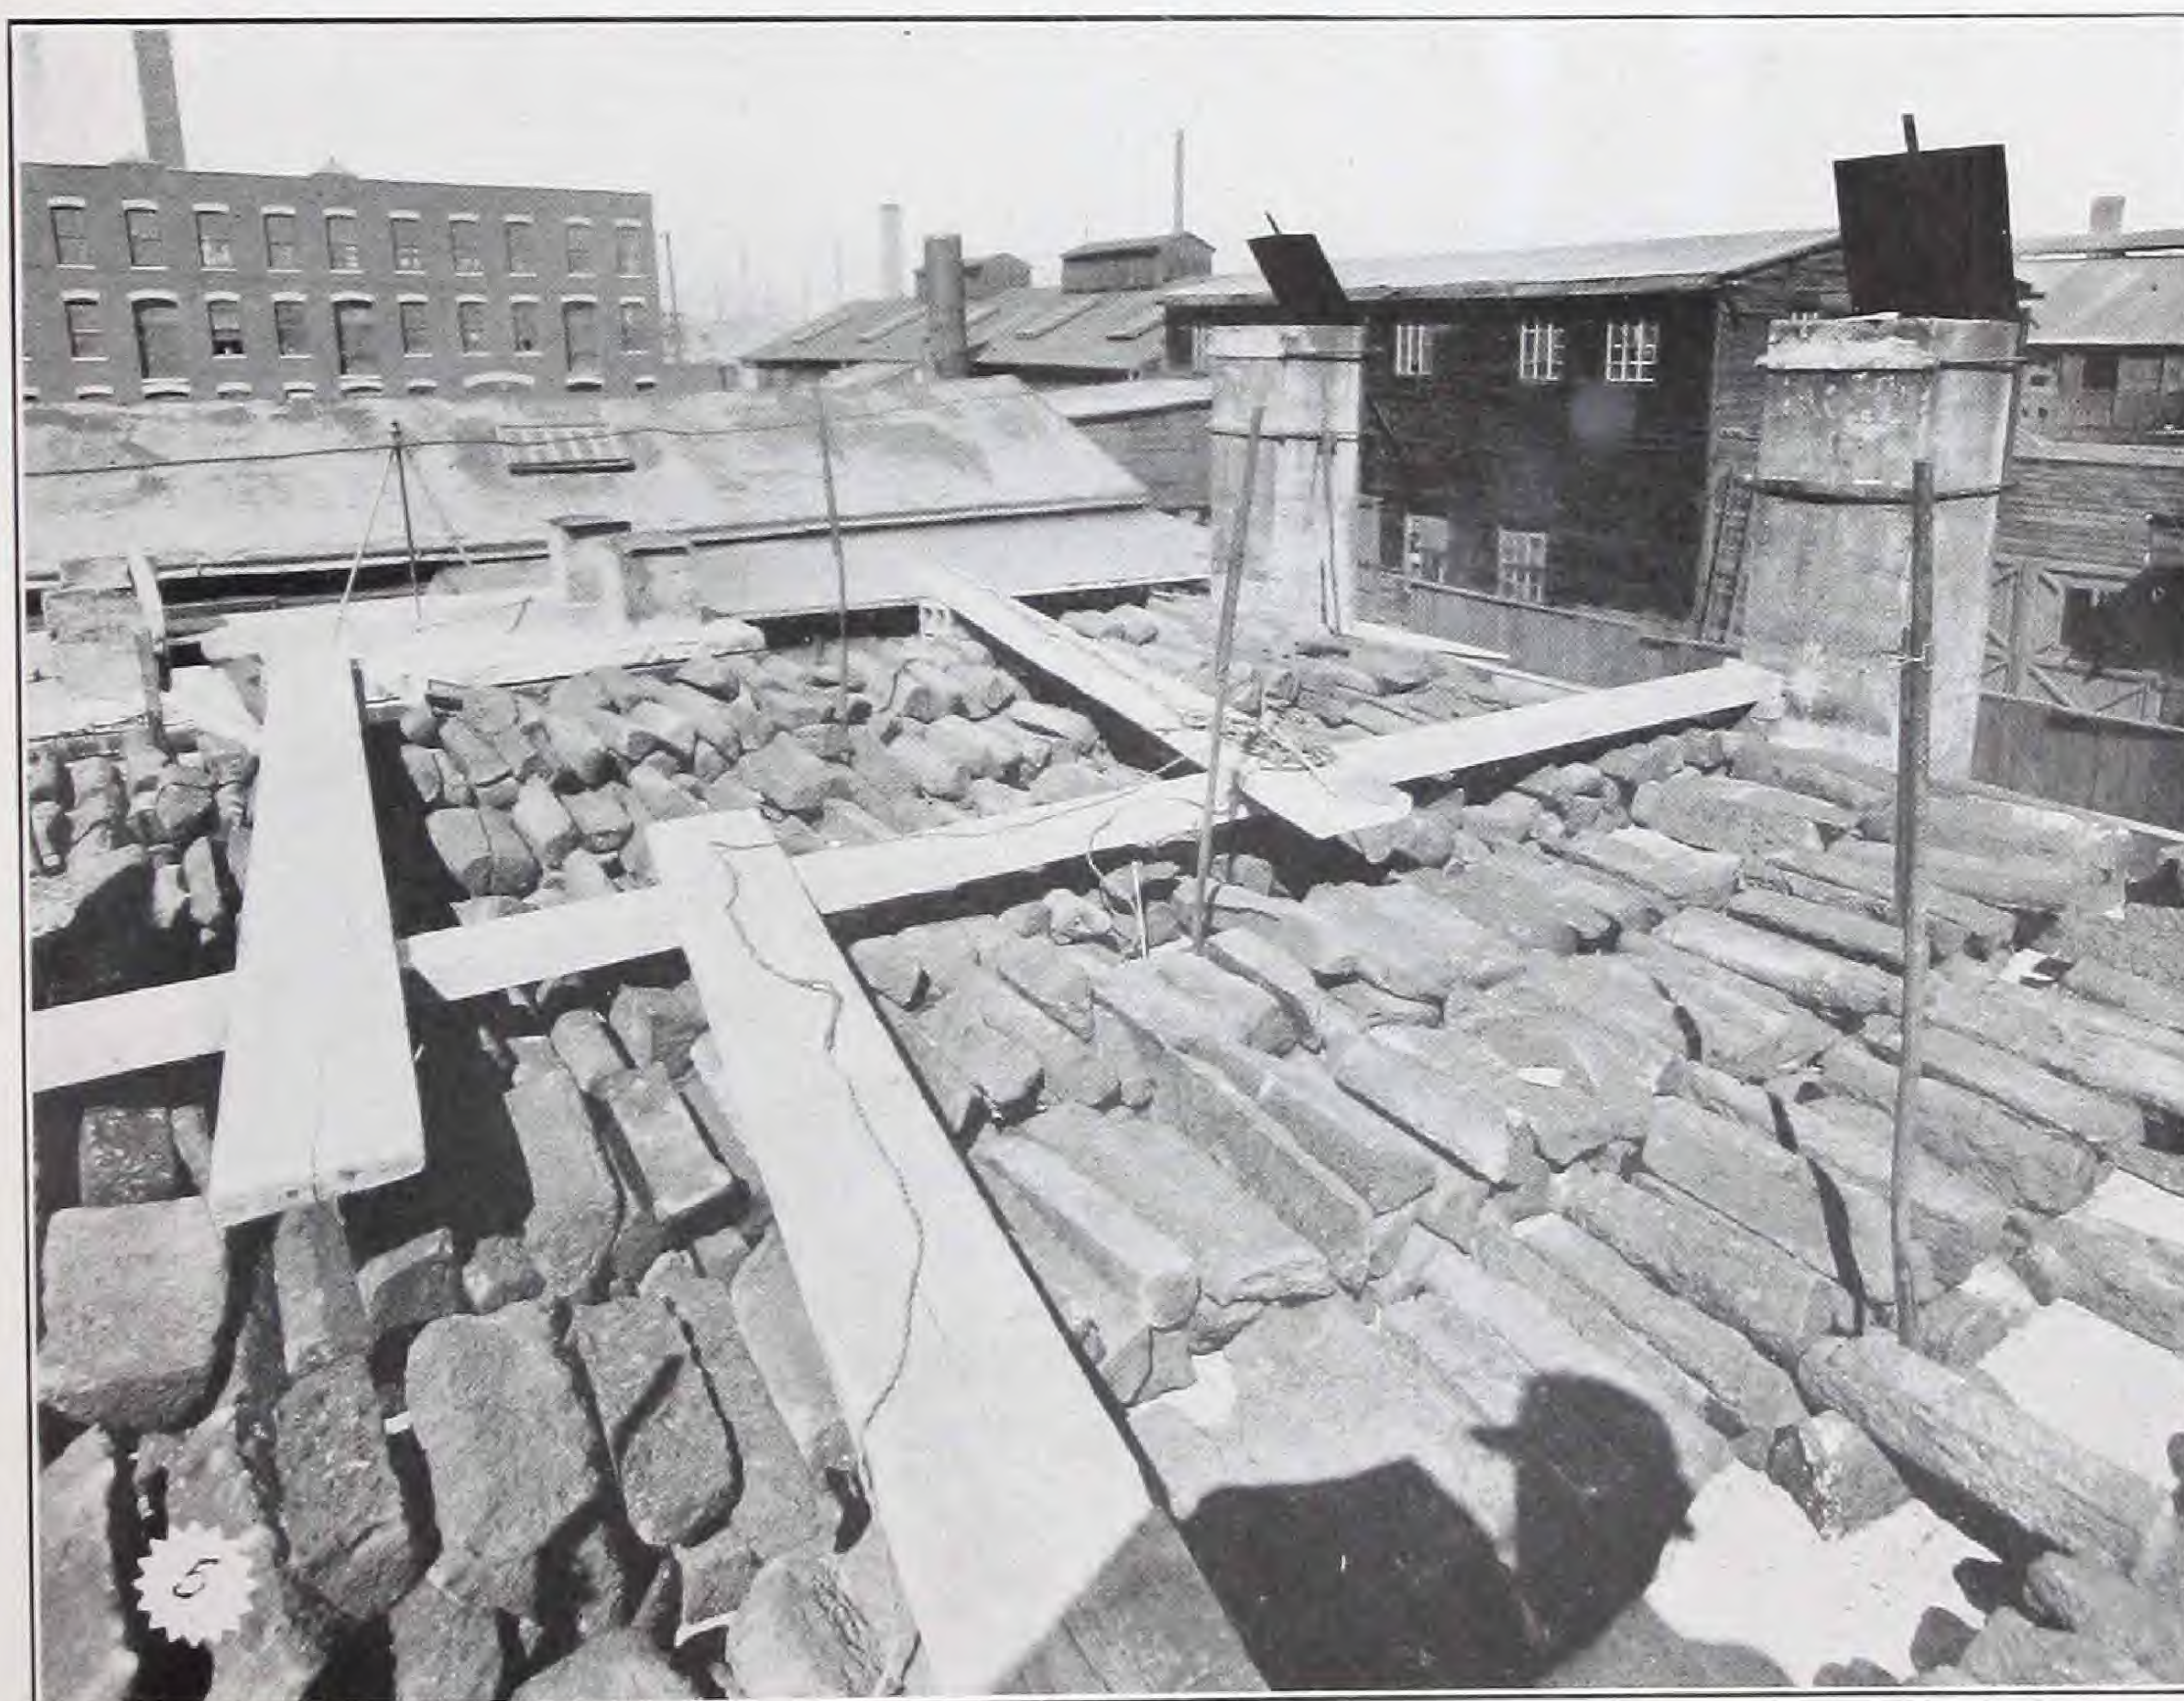
Top of Floor Just Previous to Starting the Fire. Load of 150 lbs. per Sq. Ft. in Place.
